Subject:
Former Plainwell Impoundment 2010 Bank Conditions Monitoring Report
Allied Paper, Inc./Portage Creek/Kalamazoo River Superfund Site

SEDIMENTS

**Former Plainwell Impoundment
2010 Bank Conditions Monitoring
Report**

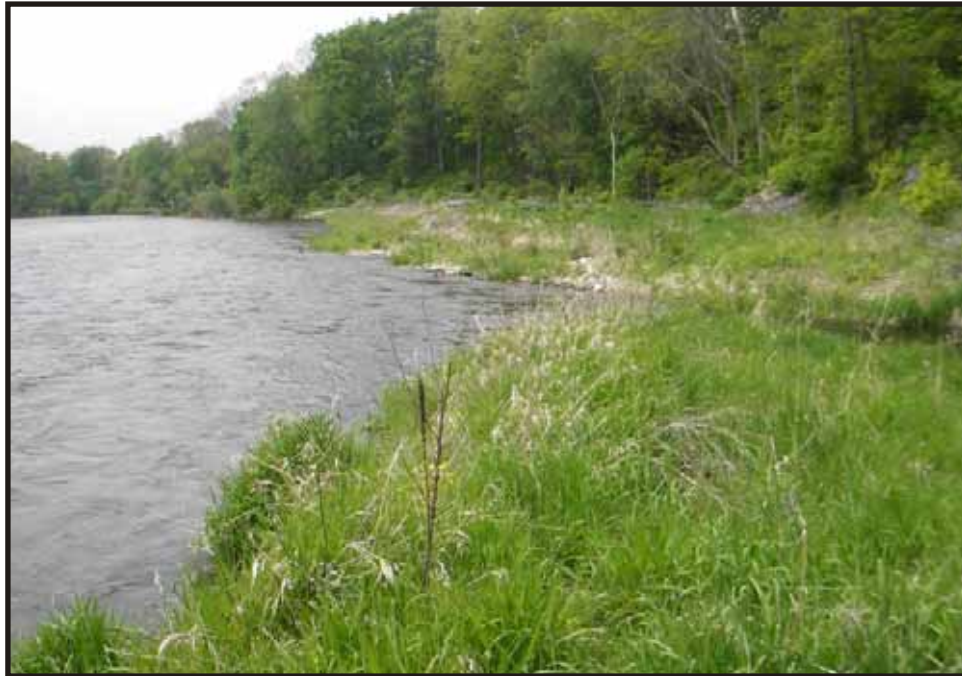
8

Photo #8: BEHI Area H on north bank immediately downstream of the US-131 bridge, looking northwest.

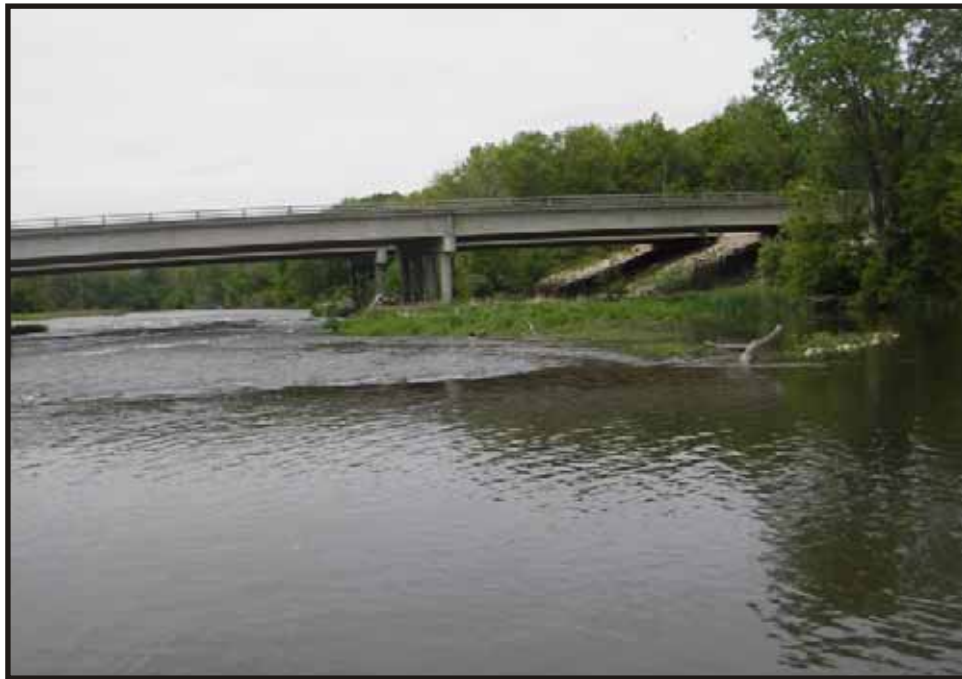
9

Photo #9: Island 3 on north bank, looking northwest from upstream.

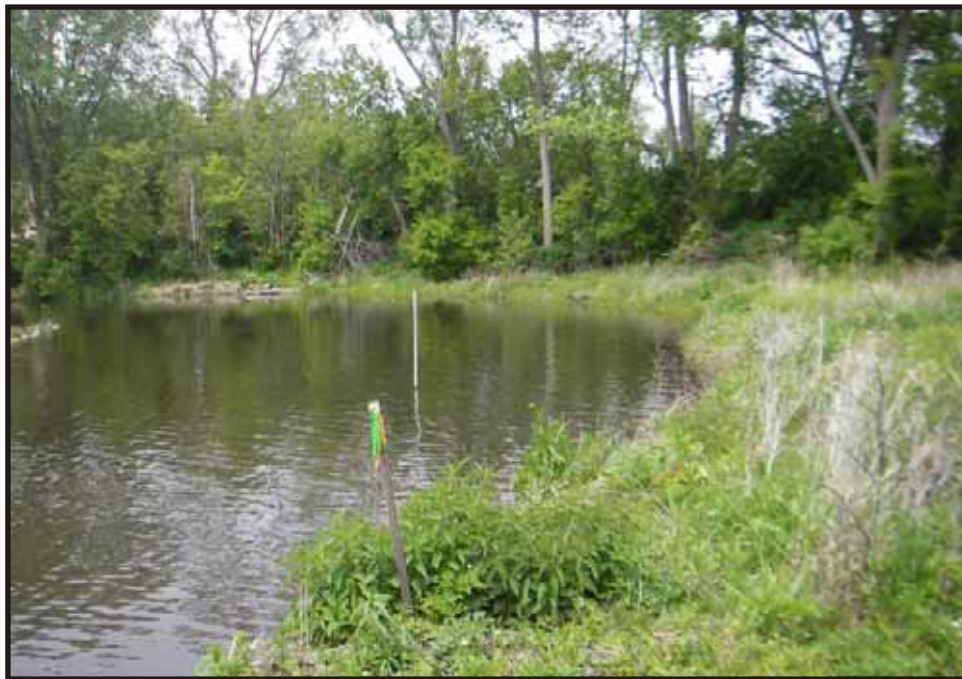
10

Photo #10: BEHI Area I2 (Very Low Erosion Potential) on north bank immediately upstream of the US-131 bridge, looking north.

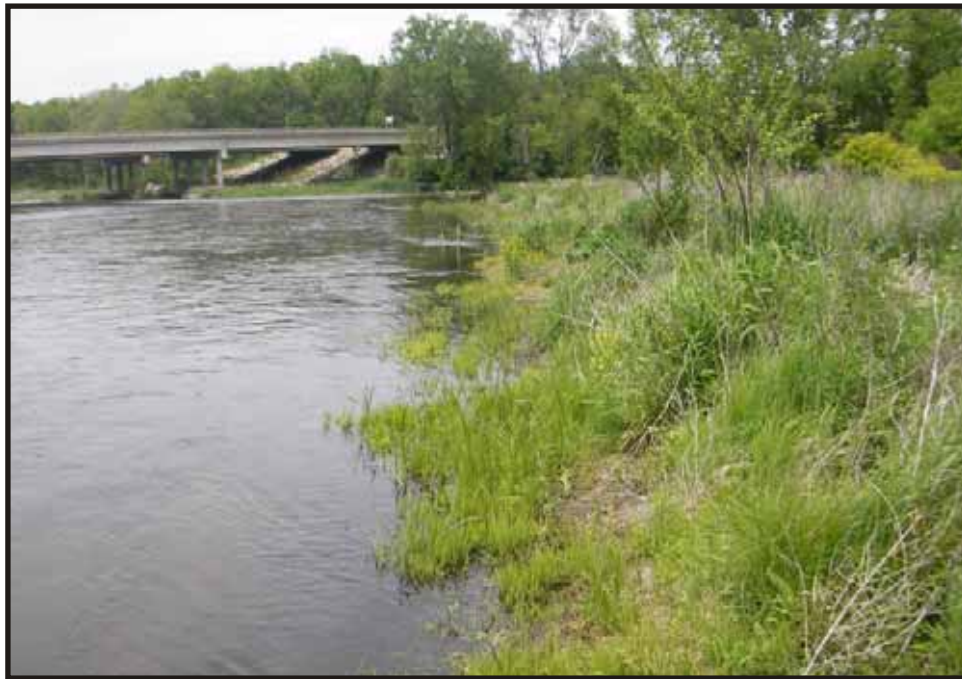
11

Photo #11: BEHI Area I2 (Very Low Erosion Potential) on north bank upstream of the US-131 bridge, looking northwest.

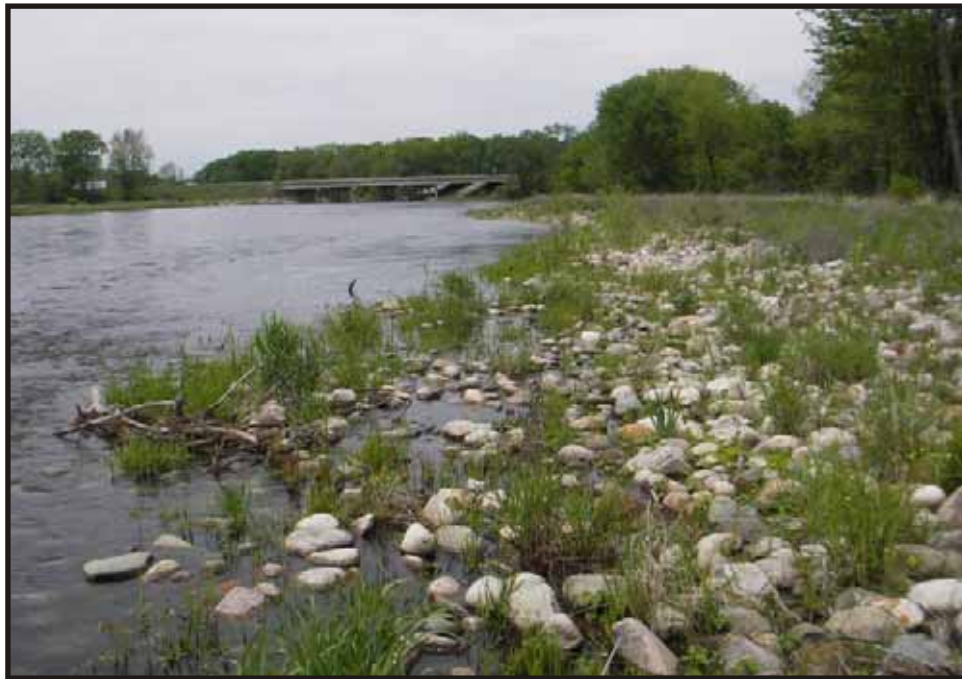
13

Photo #13: BEHI Area H2 (Very Low Erosion Potential) on north bank upstream of the US-131 bridge, looking northwest.

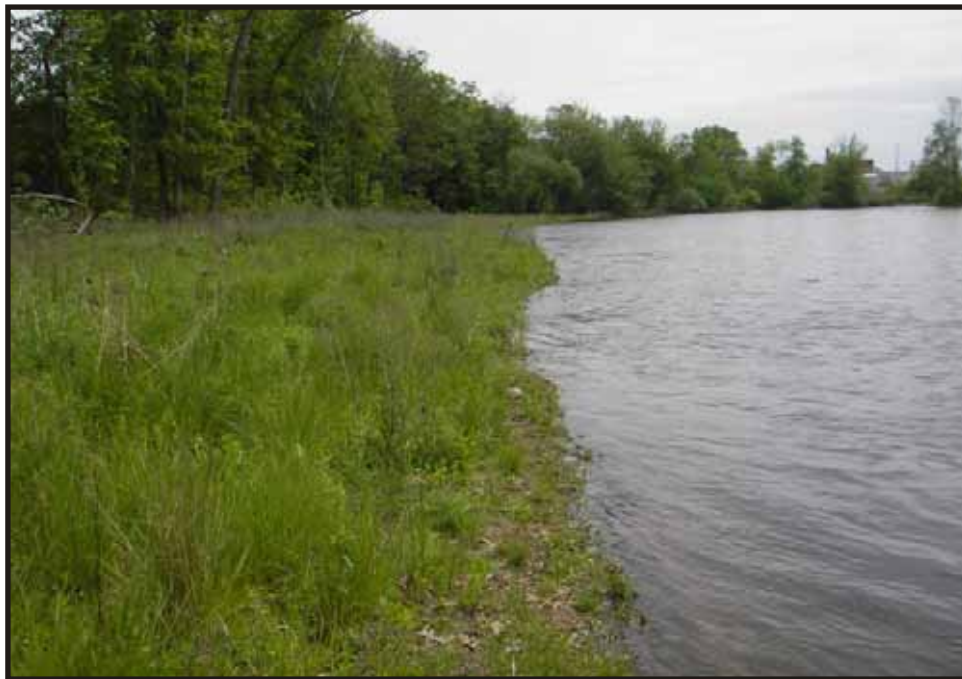
14

Photo #14: BEHI Area I1 (Very Low Erosion Potential) on north bank upstream of the US-131 bridge, looking southeast.

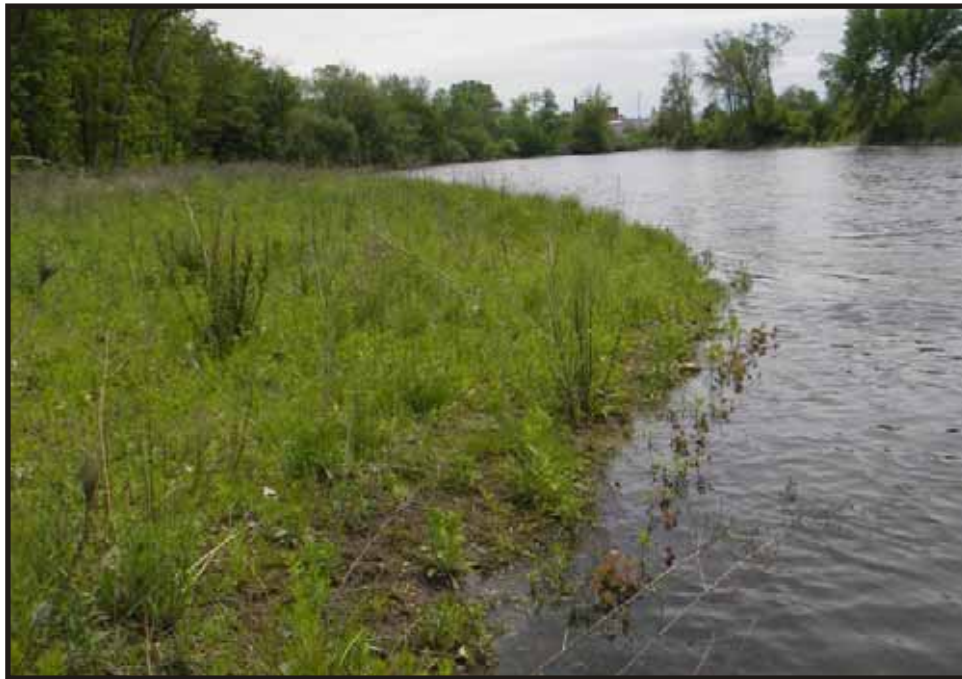
15

Photo #15: BEHI Area I1 (Very Low Erosion Potential) on north bank upstream of the US-131 bridge, looking southeast.

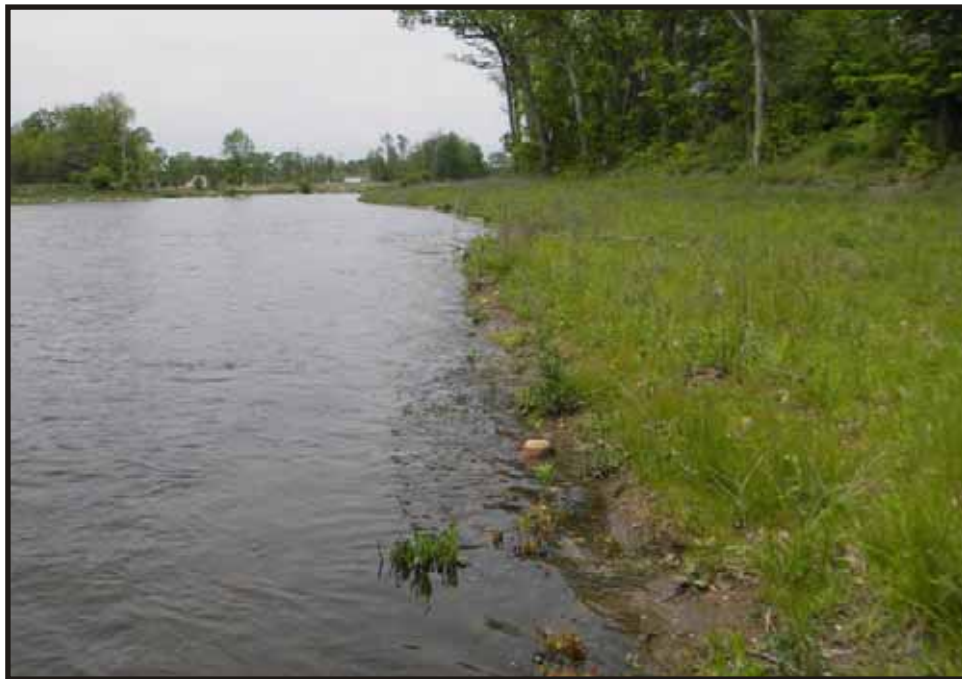
16

Photo #16: BEHI Area I1 (Very Low Erosion Potential) on north bank, looking northwest from upstream end.

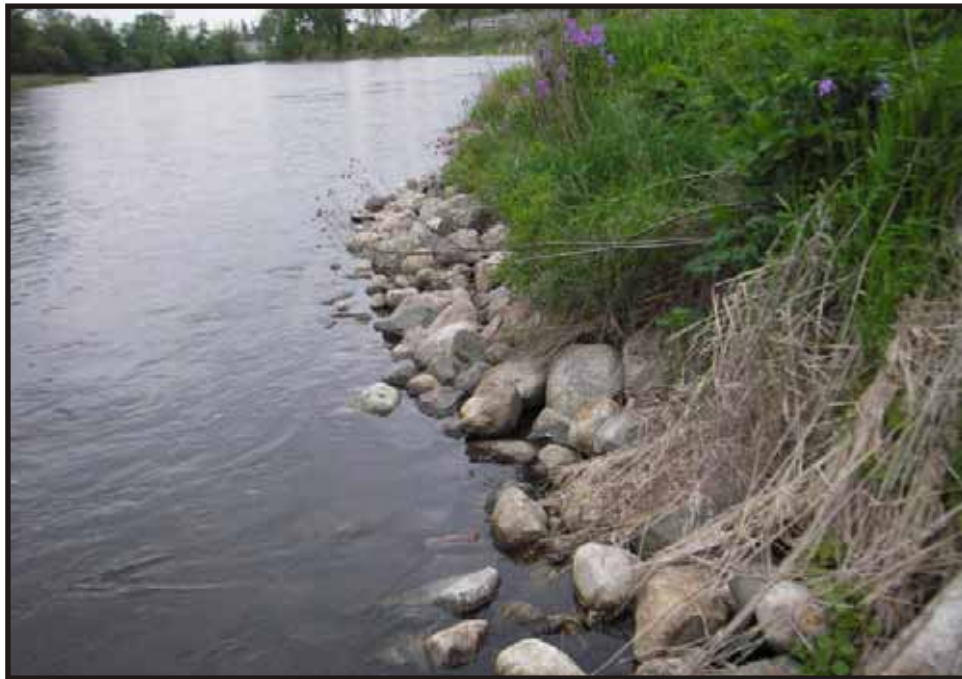
17

Photo #17: BEHI Area O (Low Erosion Potential) on south bank upstream of the US-131 bridge, looking southeast.

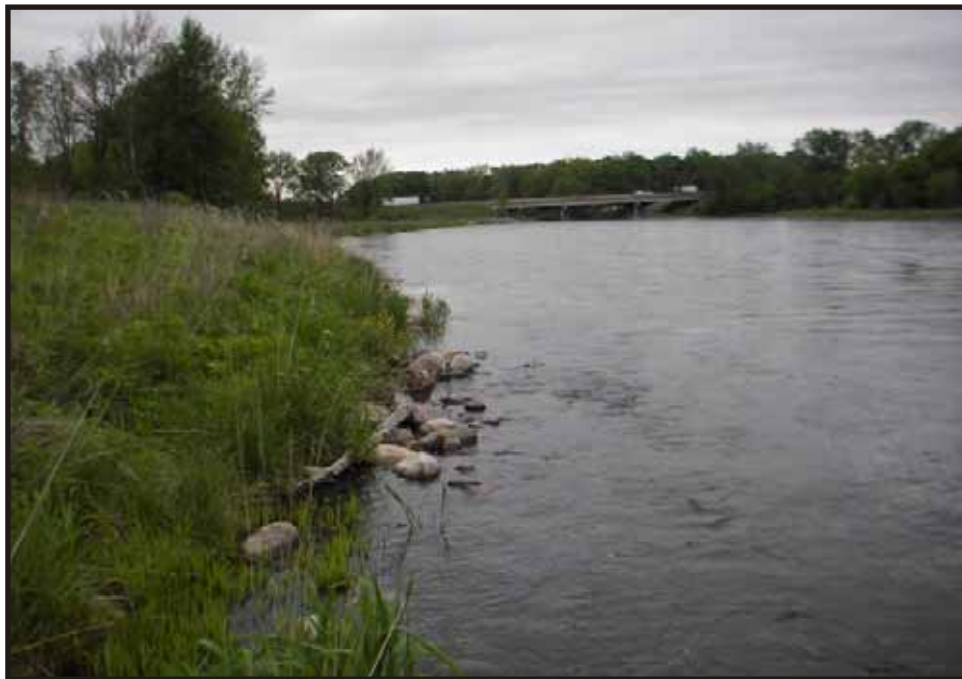
18

Photo #18: BEHI Area O1 (Low Erosion Potential) on south bank upstream of the US-131 bridge, looking west.

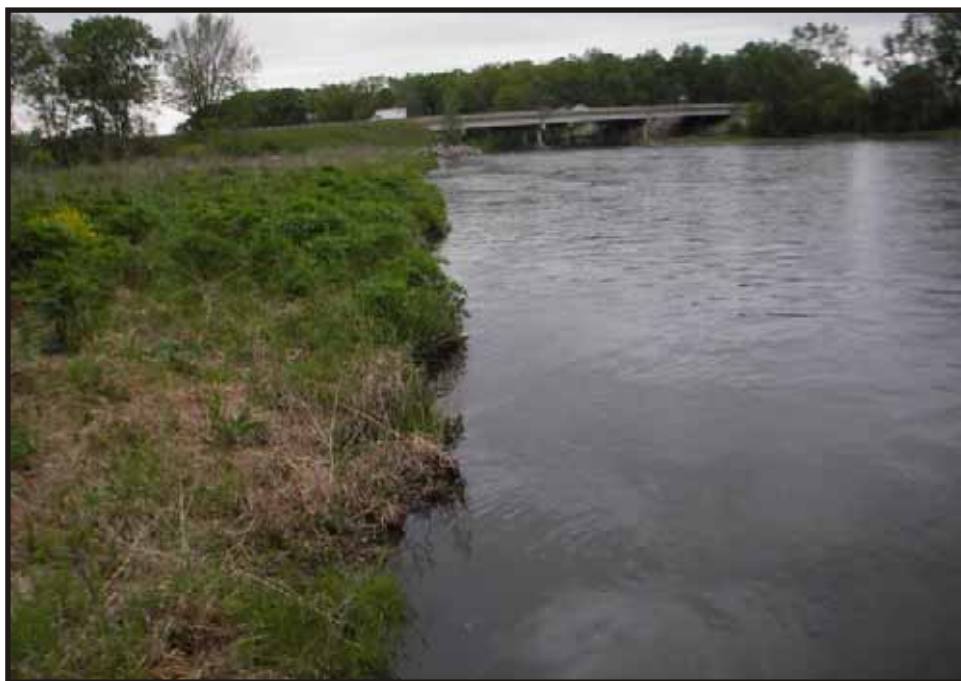
19

The portion of the south bank immediately upstream of the US-131 bridge (Labeled J1 on Figure 11) exhibited denser and deeper-rooted vegetation in 2010 than was observed in 2009. In addition, the bank angle in this area flattened from 69° to 60°. These improved characteristics decreased the BEHI rating for this section of bank from Moderate in 2009 to Low in 2010.

Photo #19: BEHI Area J1 (Low Erosion Potential) on south bank immediately upstream of the US-131 bridge, looking northwest.

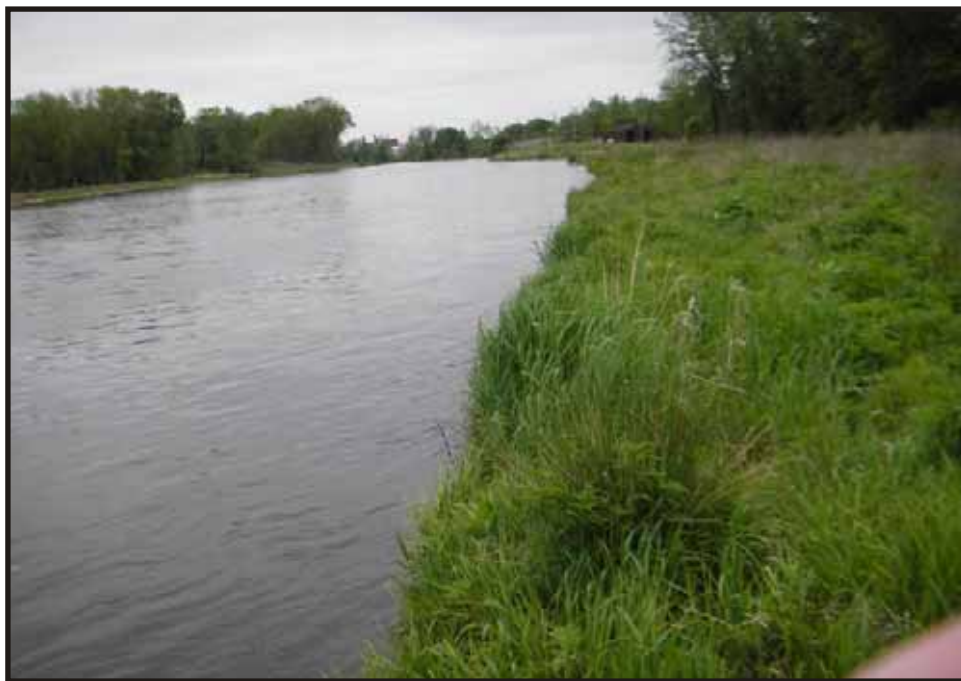
20

Photo #20: BEHI Area J1 (Low Erosion Potential) on south bank upstream of the US-131 bridge, looking southeast.

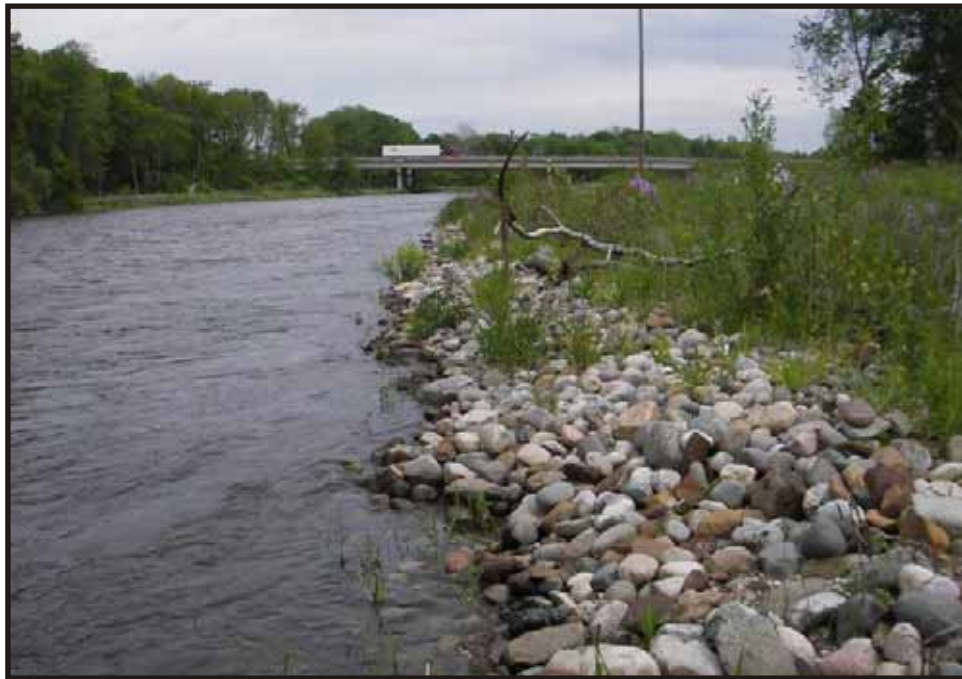
23

Photo #23: BEHI Area O2 (Low Erosion Potential) on south bank downstream of the US-131 bridge, looking east.

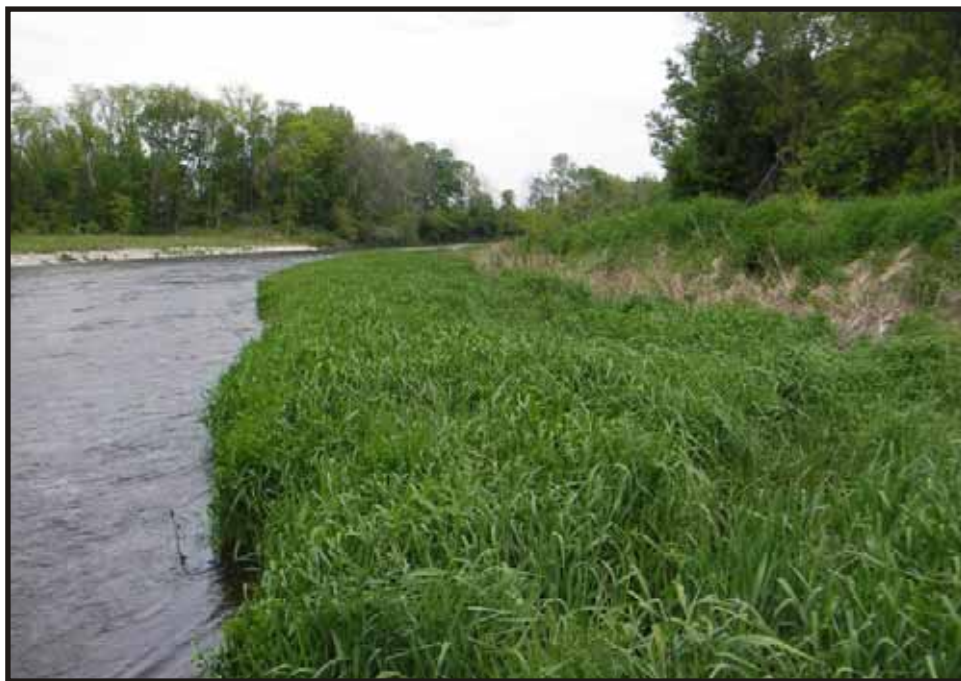
26

Photo #26: BEHI Area J2 (Low Erosion Potential) on south bank, looking northeast.

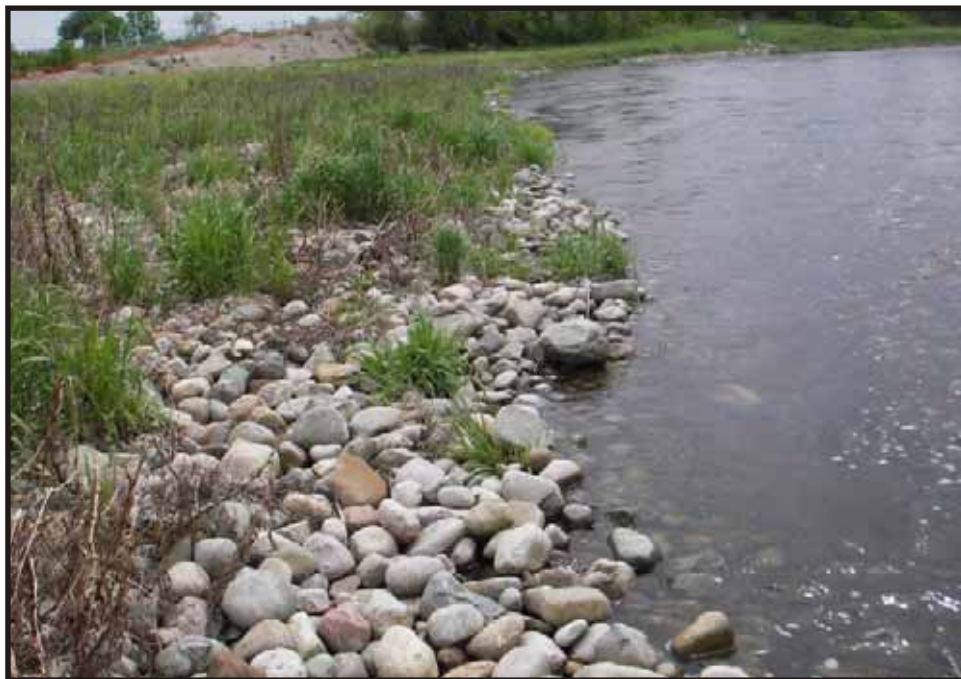
27

Photo #27: Downstream end of BEHI Area J2 (Low Erosion Potential) on south bank, looking southwest.

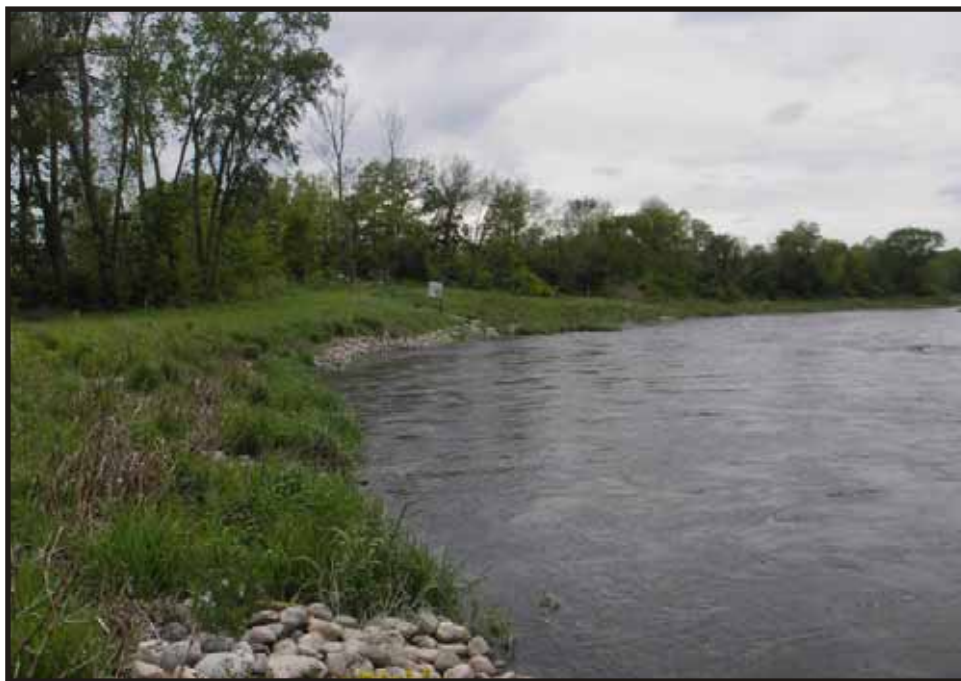
28

Photo #28: BEHI Area H on south bank, looking west.

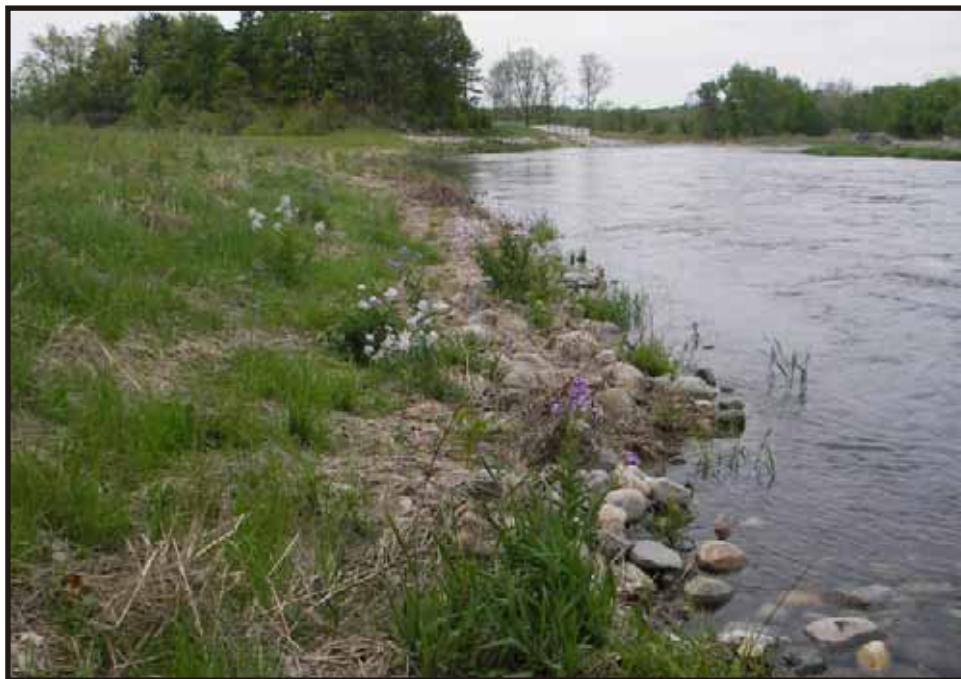
29

Photo #29: BEHI Area O3 (Low Erosion Potential) on south bank upstream of the former Plainwell Dam, looking northwest.

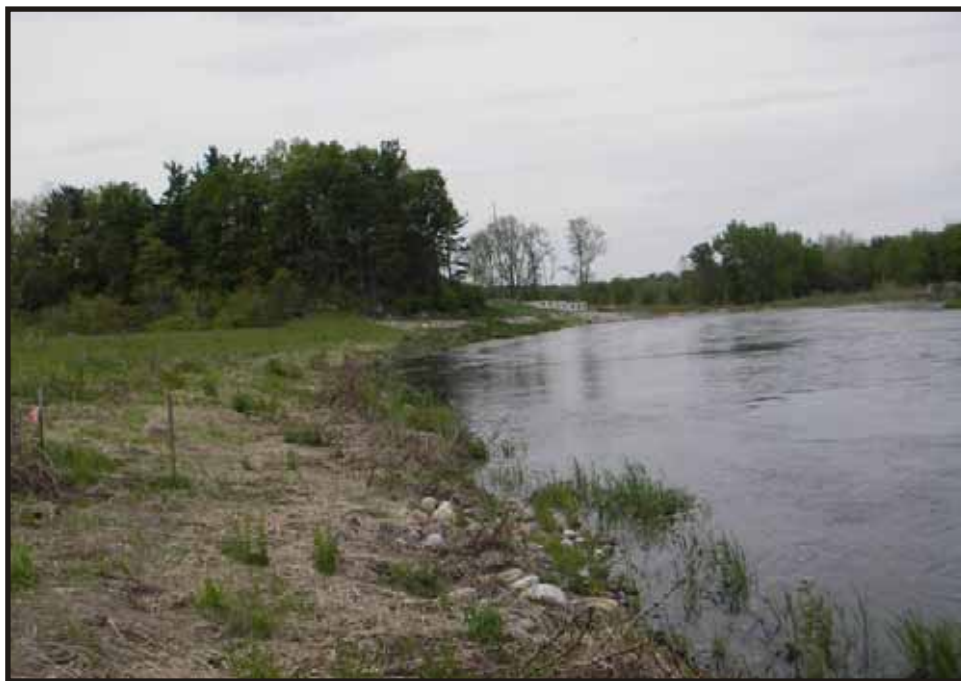
30

Photo #30: BEHI Area K1 (Low Erosion Potential) on south bank upstream of the former Plainwell Dam, looking northwest.

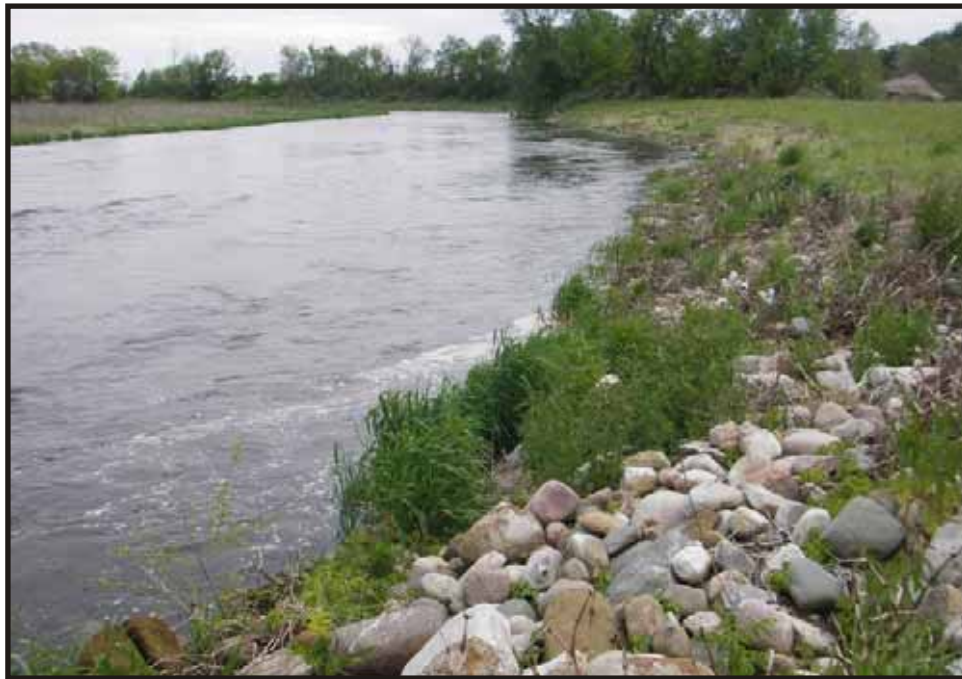
31

Photo #31: BEHI Area K1 (Low Erosion Potential) on south bank upstream of the former Plainwell Dam, looking southeast.

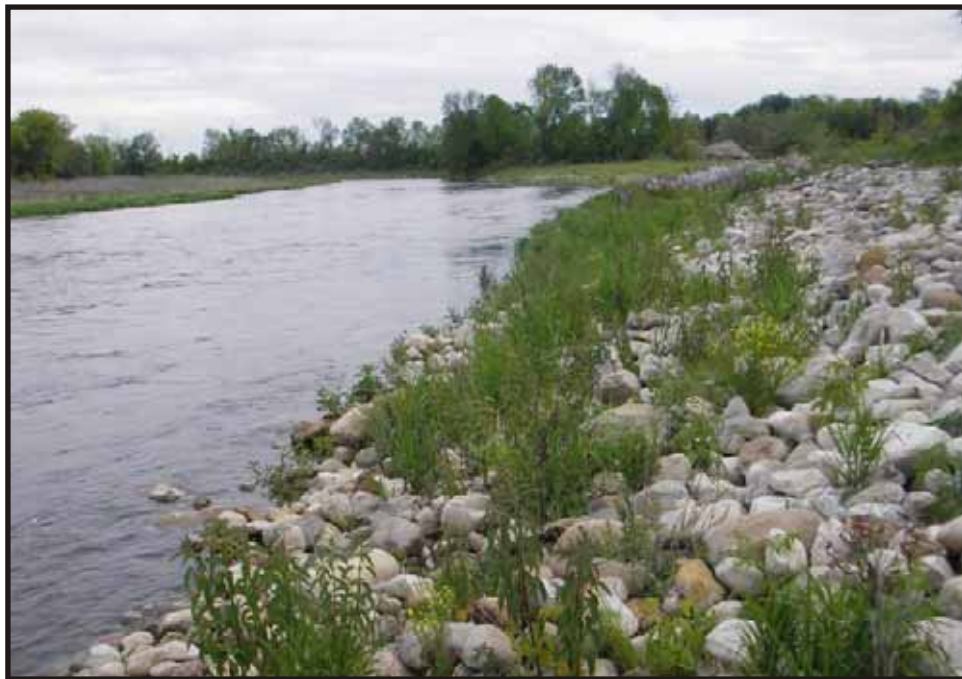
32

Photo #32: BEHI Area K1 (Low Erosion Potential) on south bank upstream of the former Plainwell Dam, looking southeast.

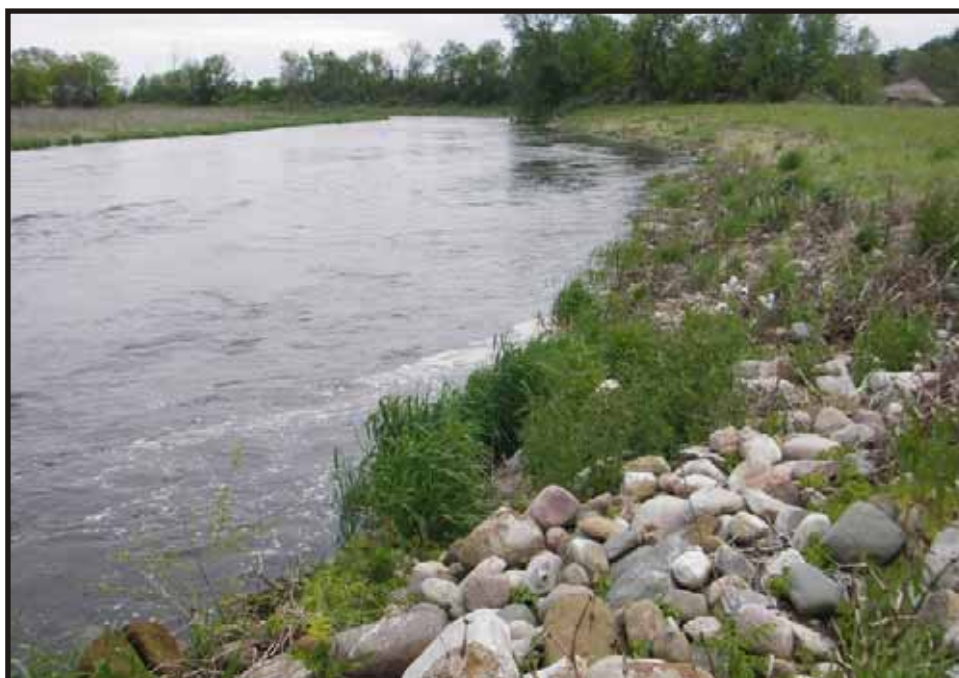
33

Photo #33: BEHI Area H (Very Low Erosion Potential) on south bank downstream of the former Plainwell Dam, looking northwest.

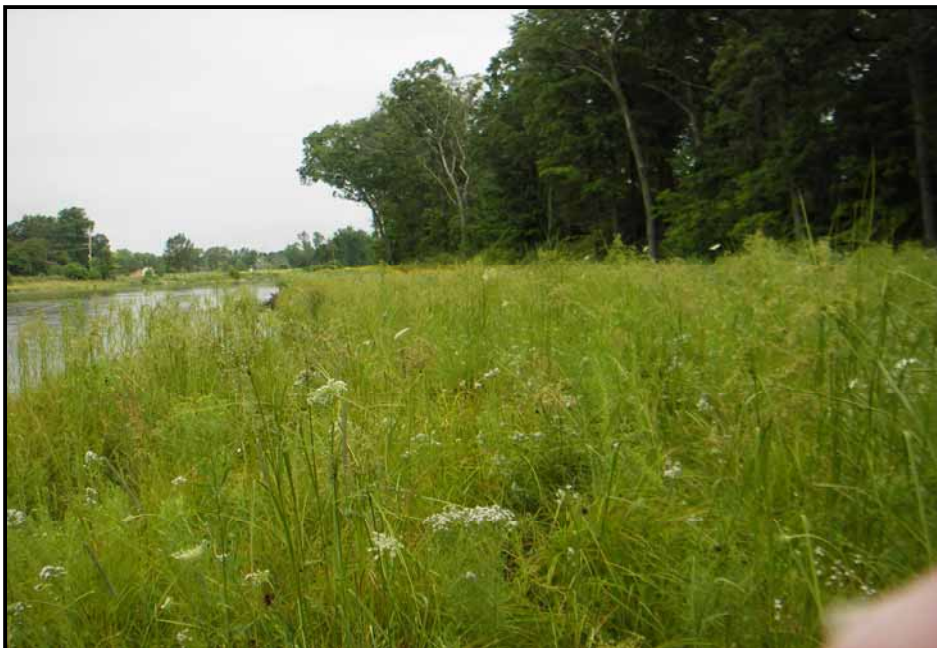
1

Photo #1: Vegetation of Removal Area 1, looking west from the east end.

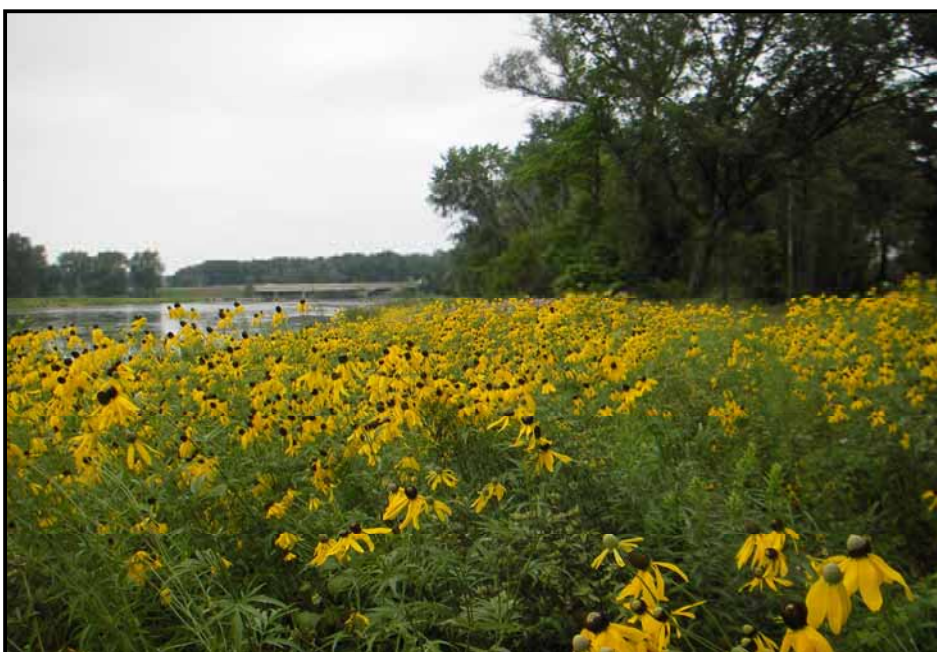
2

Photo #2: Vegetation of western portion of Removal Area 2A, looking west from the east end.

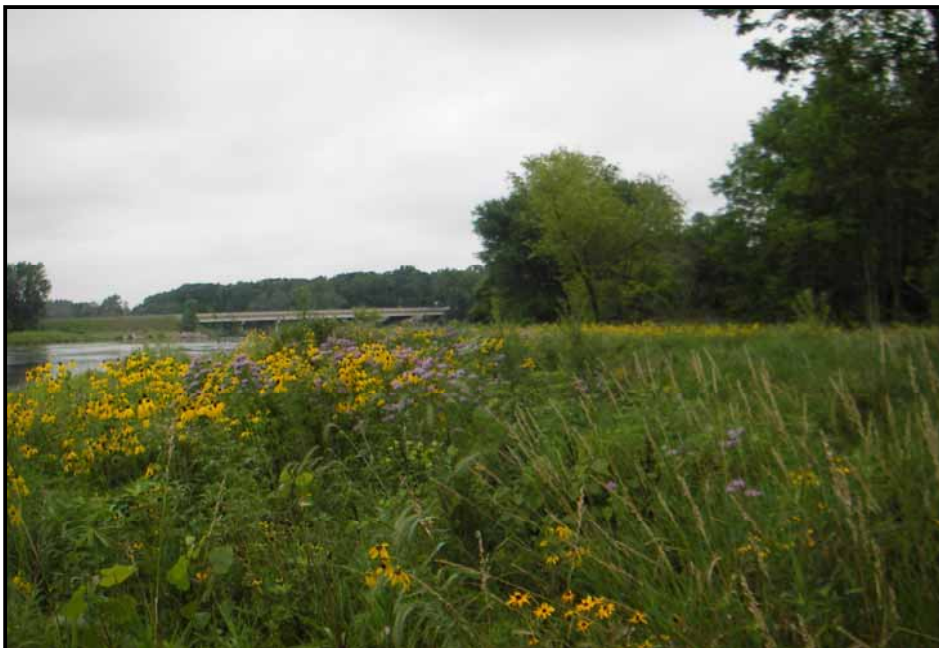
3

Photo #3: Vegetation of Removal Area 3A, looking west from the east end.

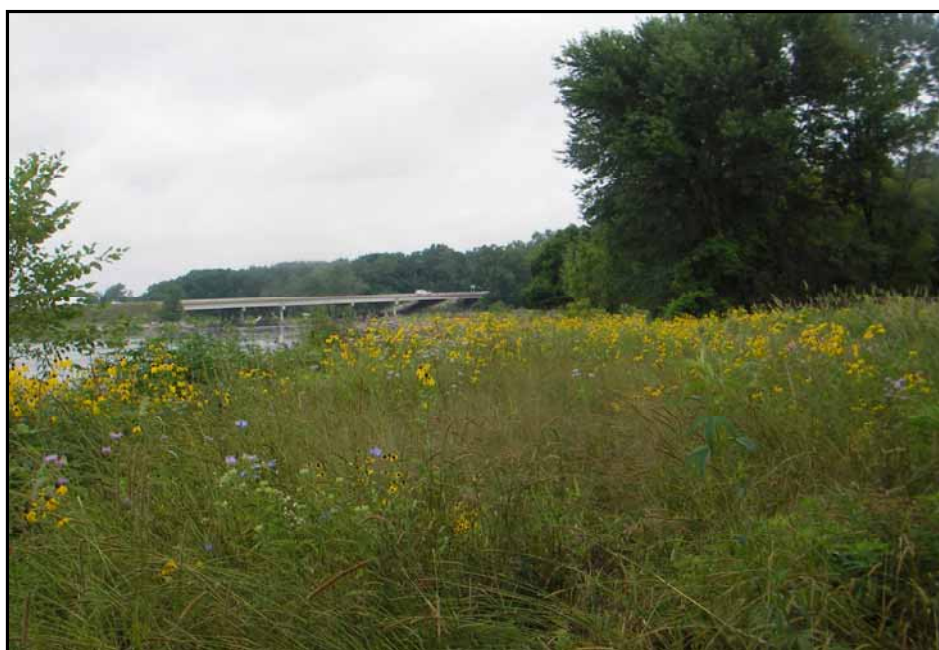
4

Photo #4: Vegetation of Removal Area 4A, looking west from the east end.

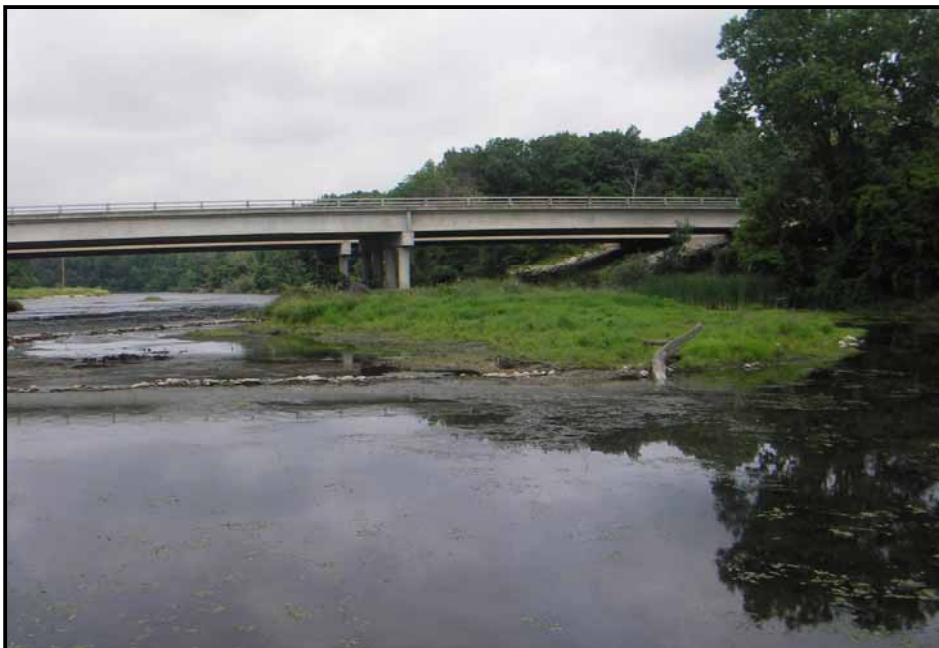
5

Photo #5: Vegetation of Island 3, looking west from east end.

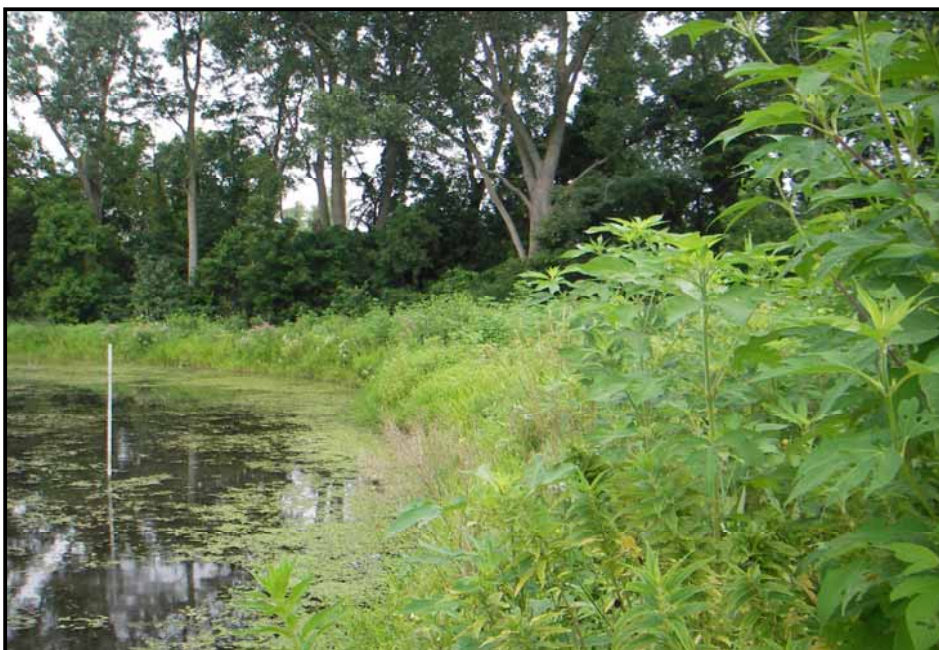
6

Photo #6: Vegetation of Removal Area 5, looking north.

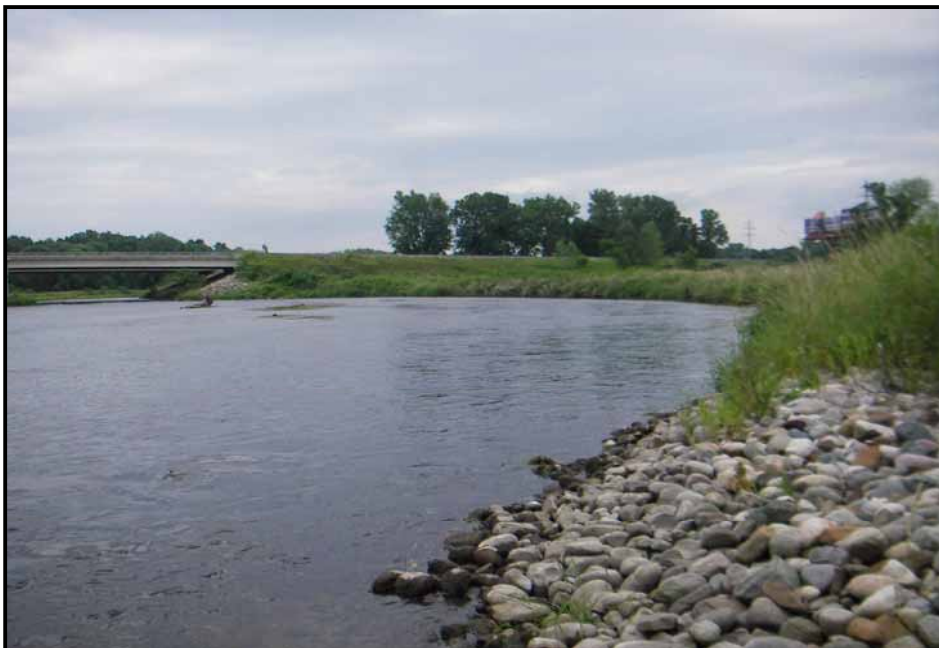
7

Photo #7: Vegetation of eastern portion of Removal Area 6B, looking east.

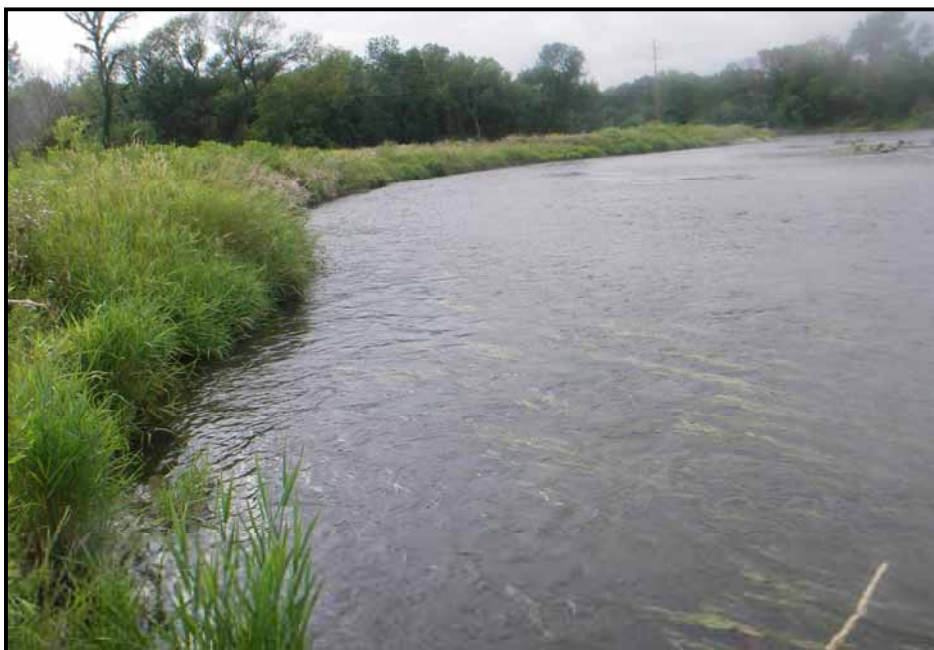
8

Photo #8: Vegetation of eastern portion of Removal Area 6B, looking west.

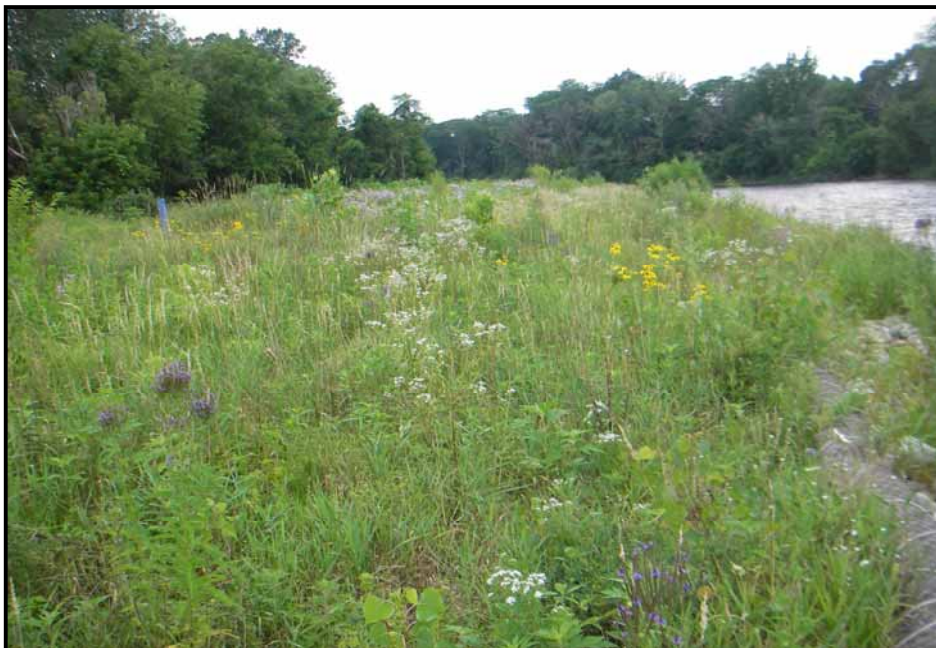
9

Photo #9: Vegetation of western portion of Removal Area 6B, looking west.

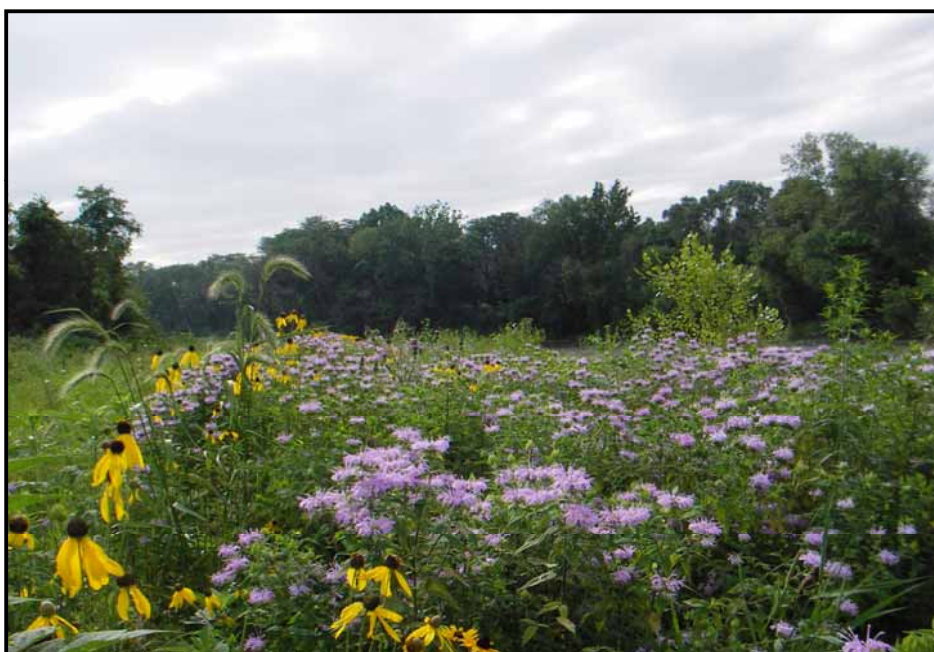
10

Photo #10: Vegetation of Removal Area 7, looking west from east end.

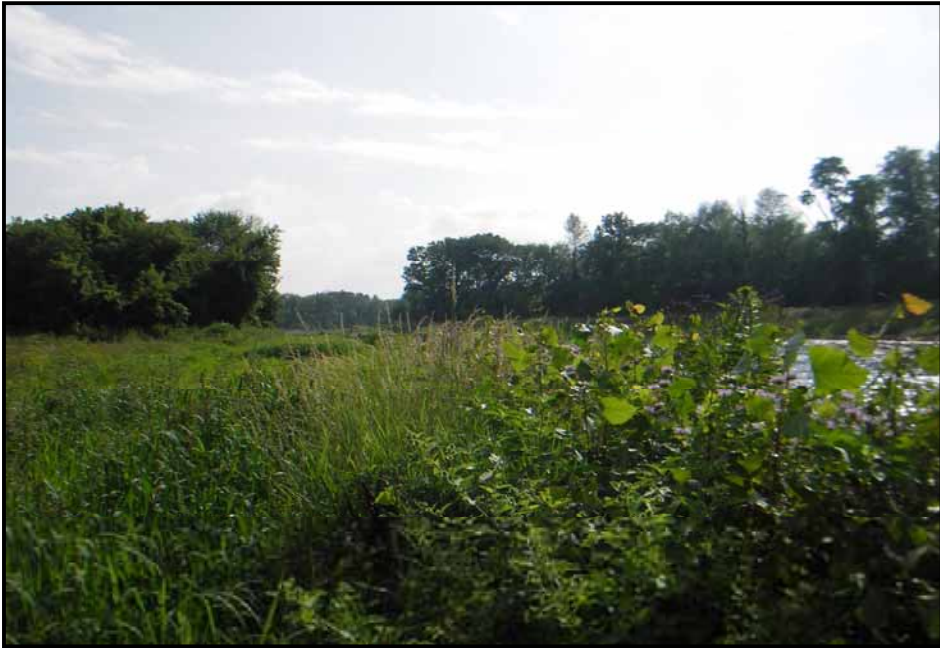
11

Photo #11: Vegetation of Removal Area 8, looking west from east end.

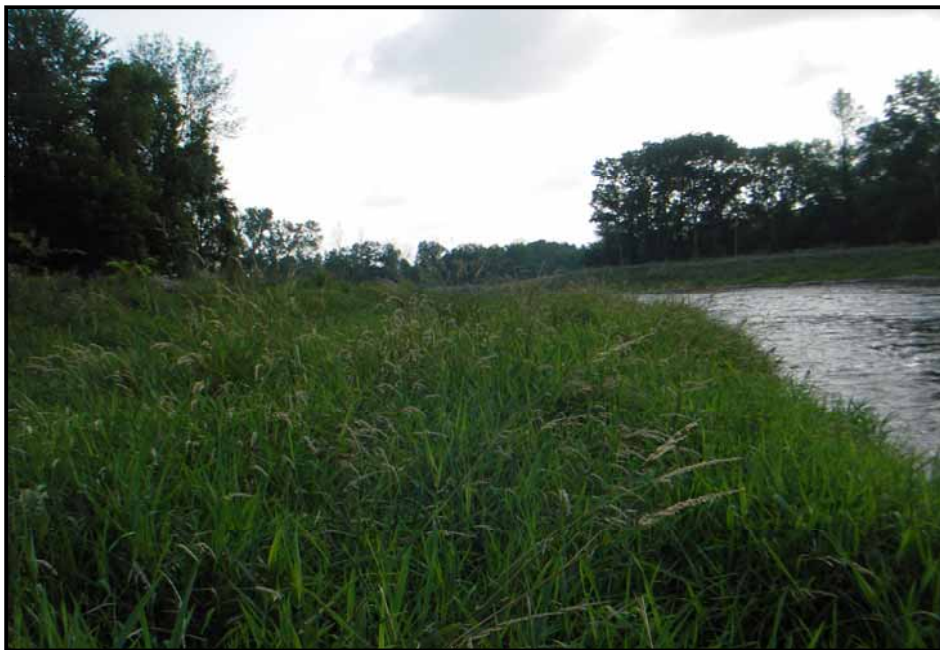
12

Photo #12: Vegetation of central portion of Removal Area 9B, looking west.

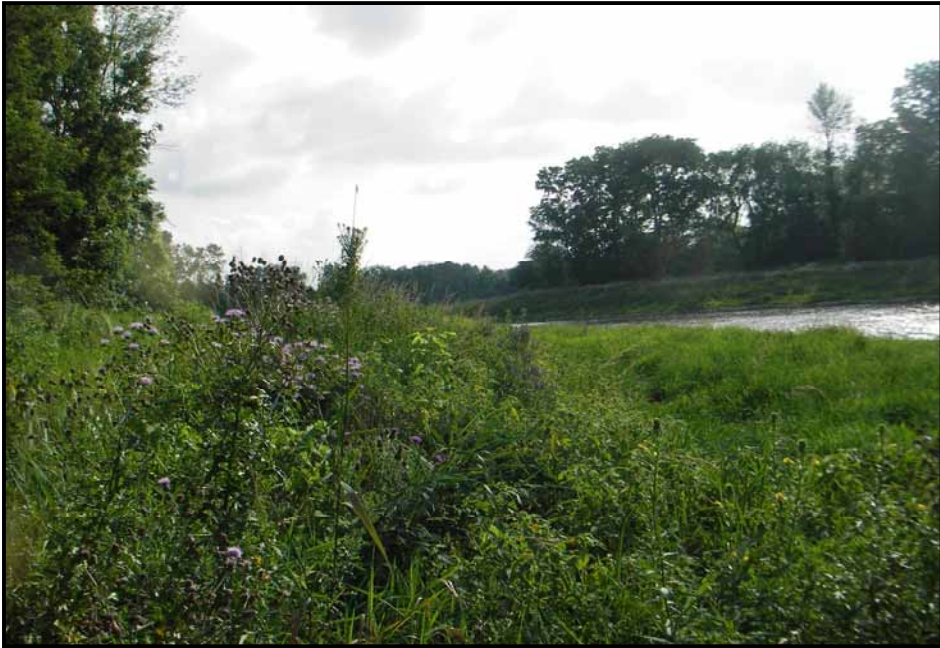
13

Photo #13: Vegetation of western portion of Removal Area 10B, looking west.

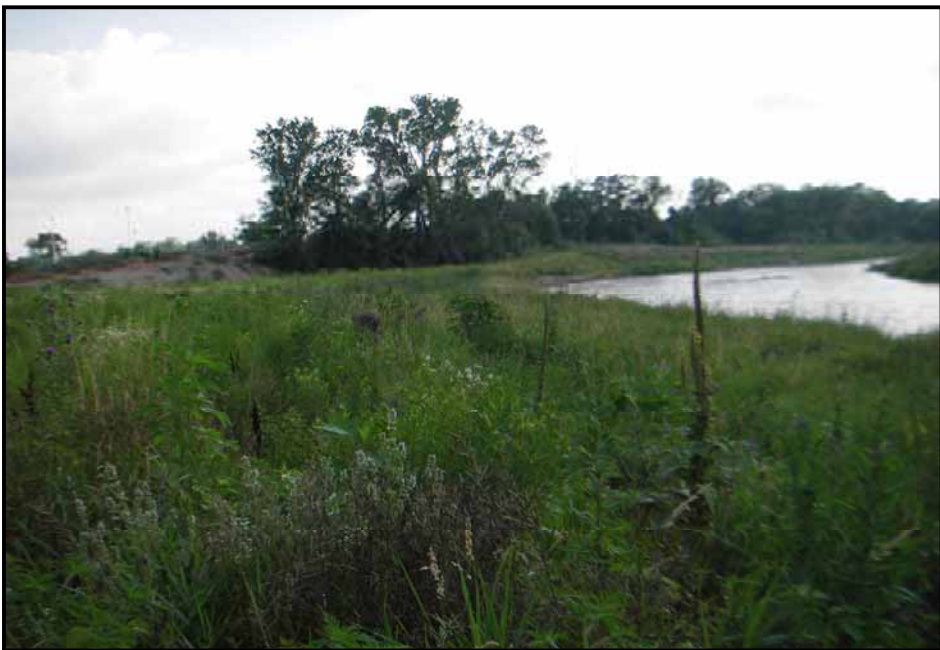
14

Photo #14: Vegetation of eastern portion of Removal Area 10B, looking west from east end.
